TROUT RUN DAM

PHASE I INSPECTION REPORT NATIONAL DAM INSPECTION PROGRAM

11
SEPTEMBER 1978

TROUT RUN DAM
BERKS COUNTY, PENNSYLVANIA
NATIONAL I.D. NO. PA 00797

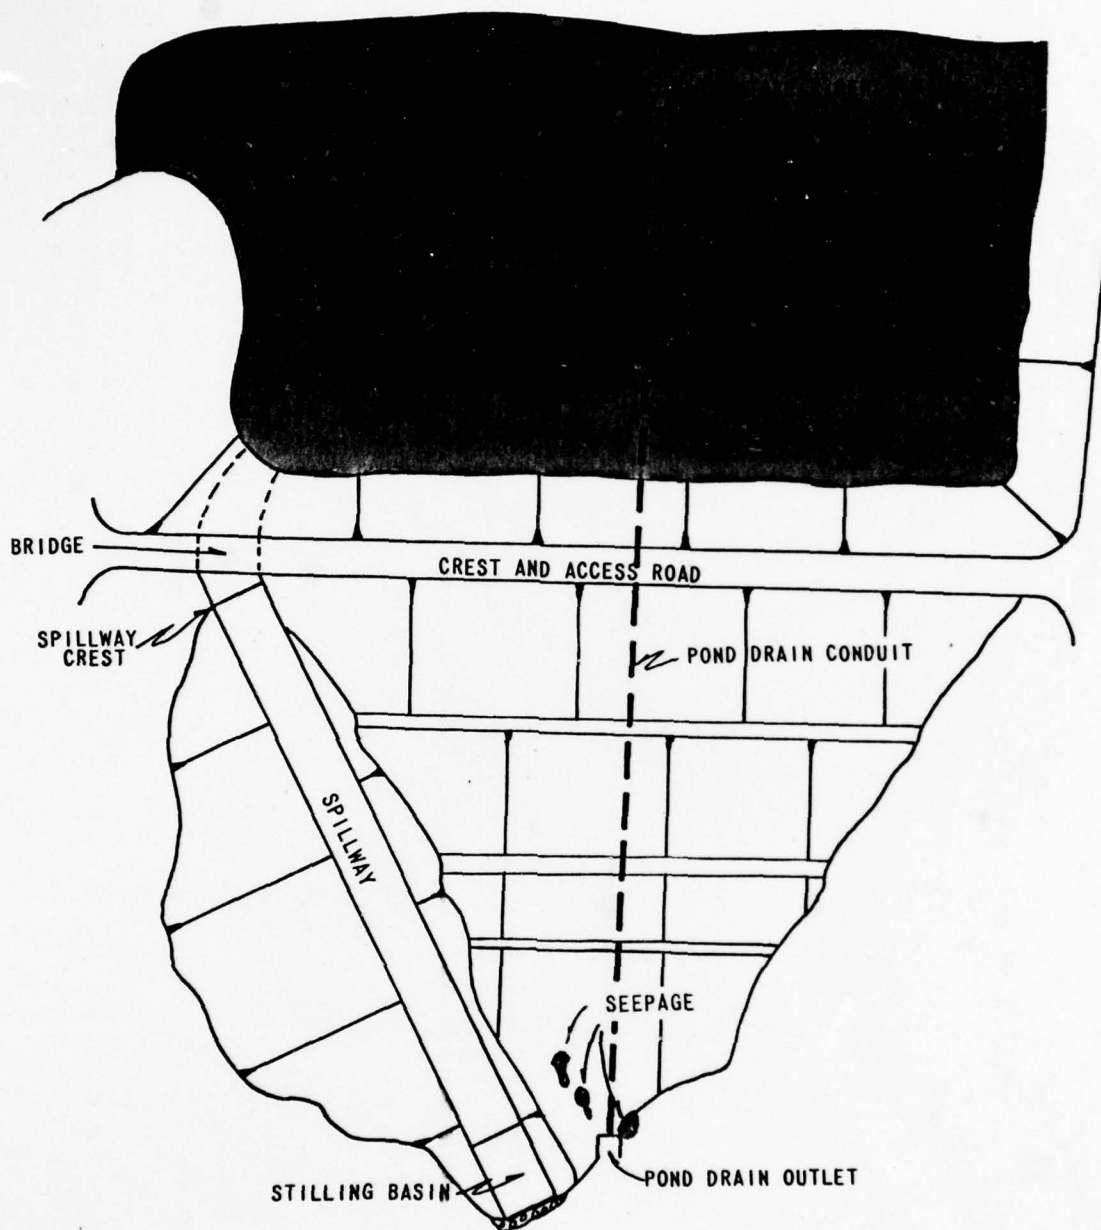
SHEET 5a OF 11

The drainage pipes located through the walls of the impact basin were inspected. Water was not flowing from these pipes. However, as shown on Sheet 5a, Appendix B, some seepage was noted immediately above and through the rock toe drain approximately 40 feet upslope from the toe and immediately above the impact basin. The seepage was estimated to be less than 2 gallons per minute. This seepage was emanating from approximately elevation 537. This corresponds closely to the junction between the rock toe and the select fill embankment. This location is approximate and based on a visual inspection of the embankment and comparison with the typical cross-sections, as shown on Plate 4, Appendix E. It is not known what the cause of this seepage is, but there is the possibility that the 3-layer filter blanket is partially clogged and that the water is passing over the top of the blanket and emanating at the surface.

As shown on Sheet 5a in Appendix B and discussed in Section 3, seepage was noted through the downstream embankment at a rate of less than 2 gallons per minute. Evidence on the slope indicates that this seepage is relatively constant. Considering the location of this seepage and the fact that the weep holes on the impact basin were not discharging, an undesirable seepage condition is evident and should be investigated.

*Yes. See sheet 5a. Some slight seepage was noted through the rock
toe drain about 40 feet (slope distance) upslope from the toe. The
rate was estimated to be less than two gpm.*

1. It is recommended that the seepage noted through the rockfill toe as shown on Sheet 5a, Appendix B be inspected and evaluated by a registered professional engineer.
2. The flow discharging from the pond drain pipe should be investigated to determine the source of the discharge.

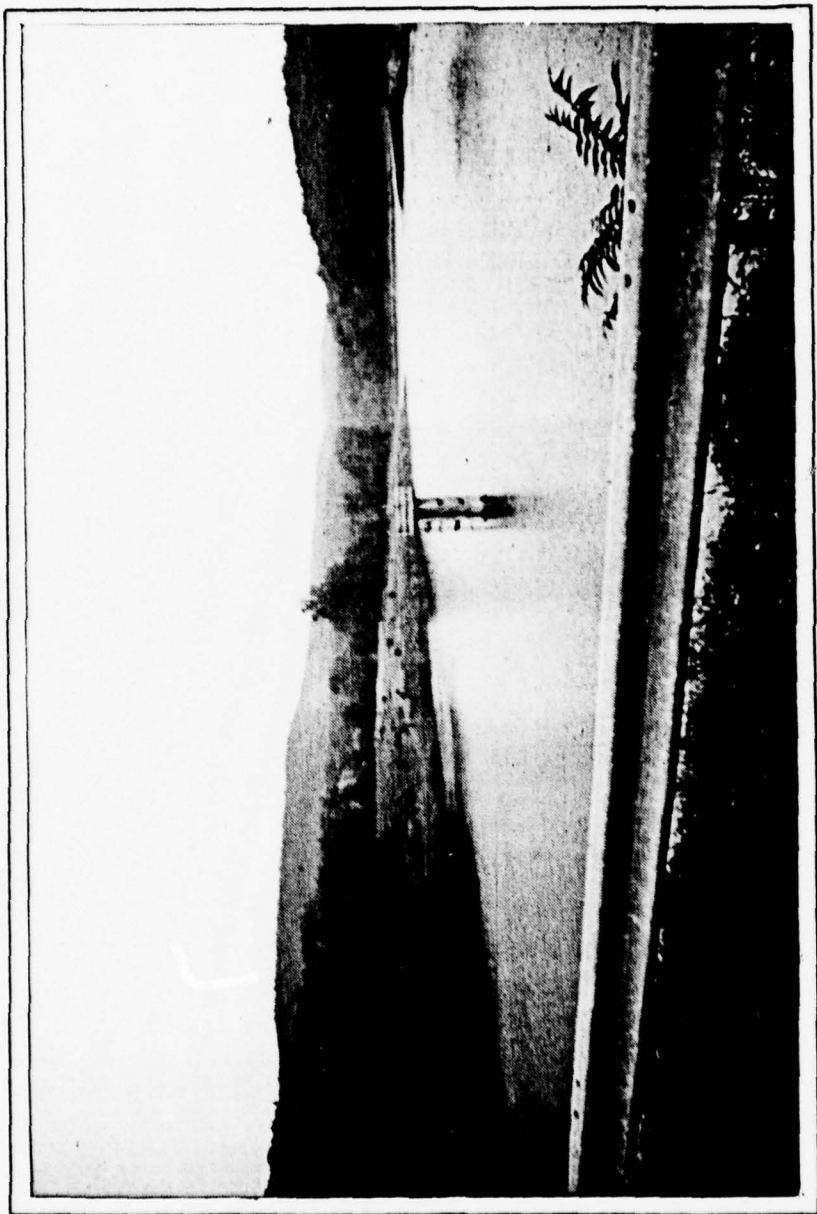
PHOTOGRAPH NO. 1

As the outlet tower is located approximately 260 feet from the crest of the dam, and there is no access bridge to the tower, an inspection of the tower could not be performed nor could the valves be exercised. However, the tower was observed through a telephoto lens, and the portions exposed above the water level appeared to be in good condition, with no signs of distress, concrete spalling or unusual cracks. The ARMCO valves were visually inspected from the same vantage point and appeared to be in good condition and clean.

WATER SUPPLY INTAKE TOWER.

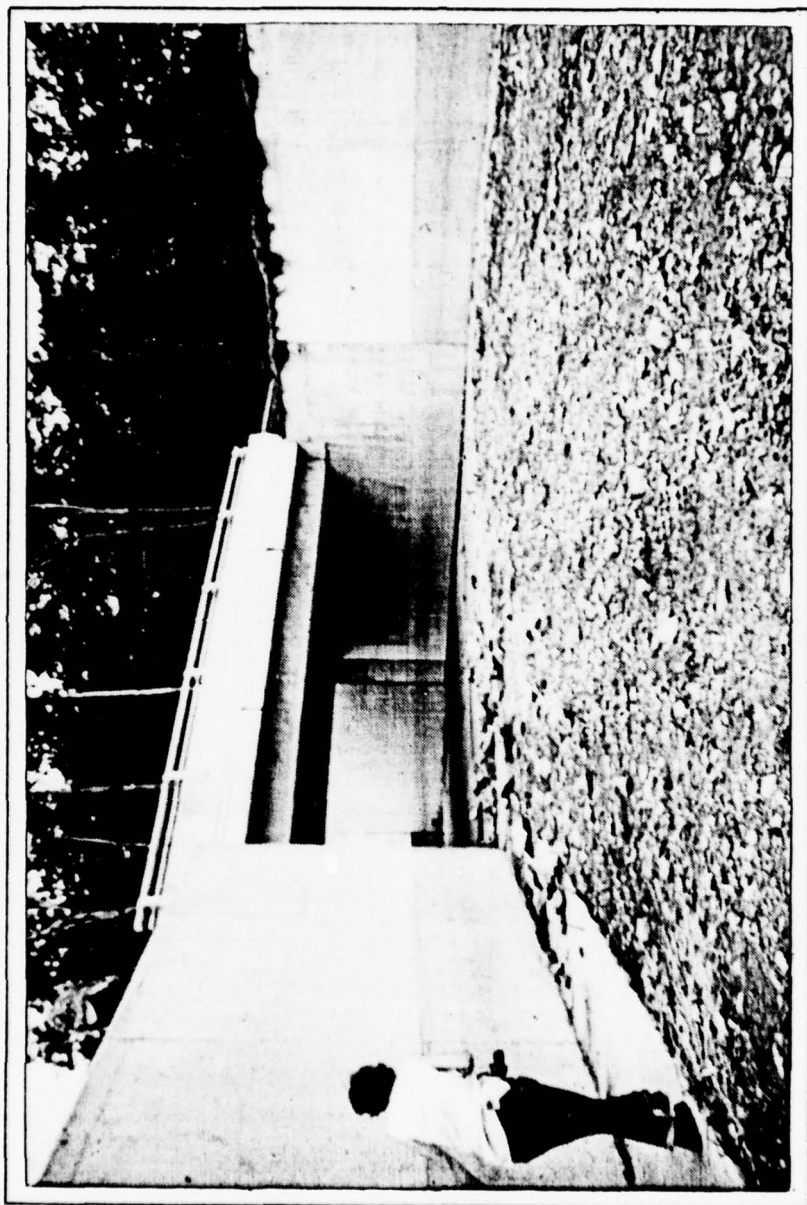
PHOTOGRAPH NO. 4

SPILLWAY APPROACH CHANNEL.

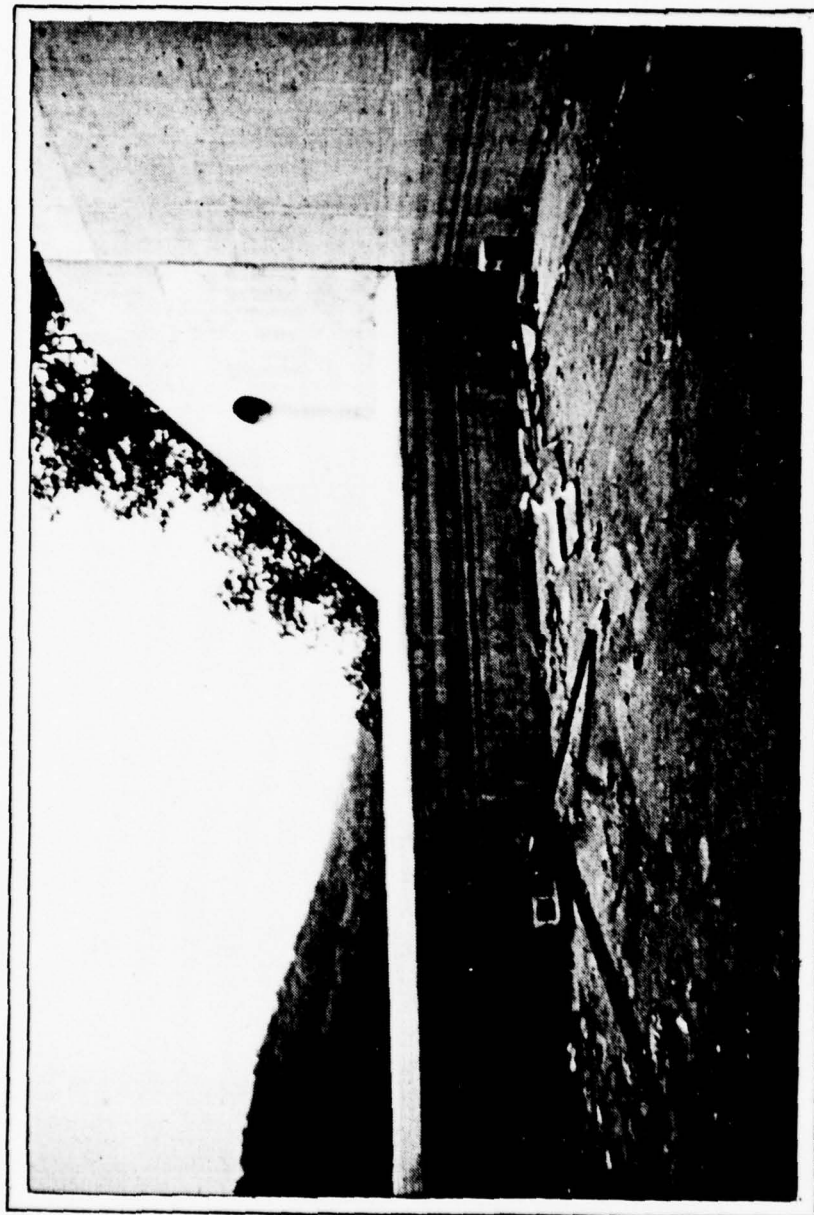
PHOTOGRAPH NO. 5

VIEW OF SPILLWAY OGEE SECTION.

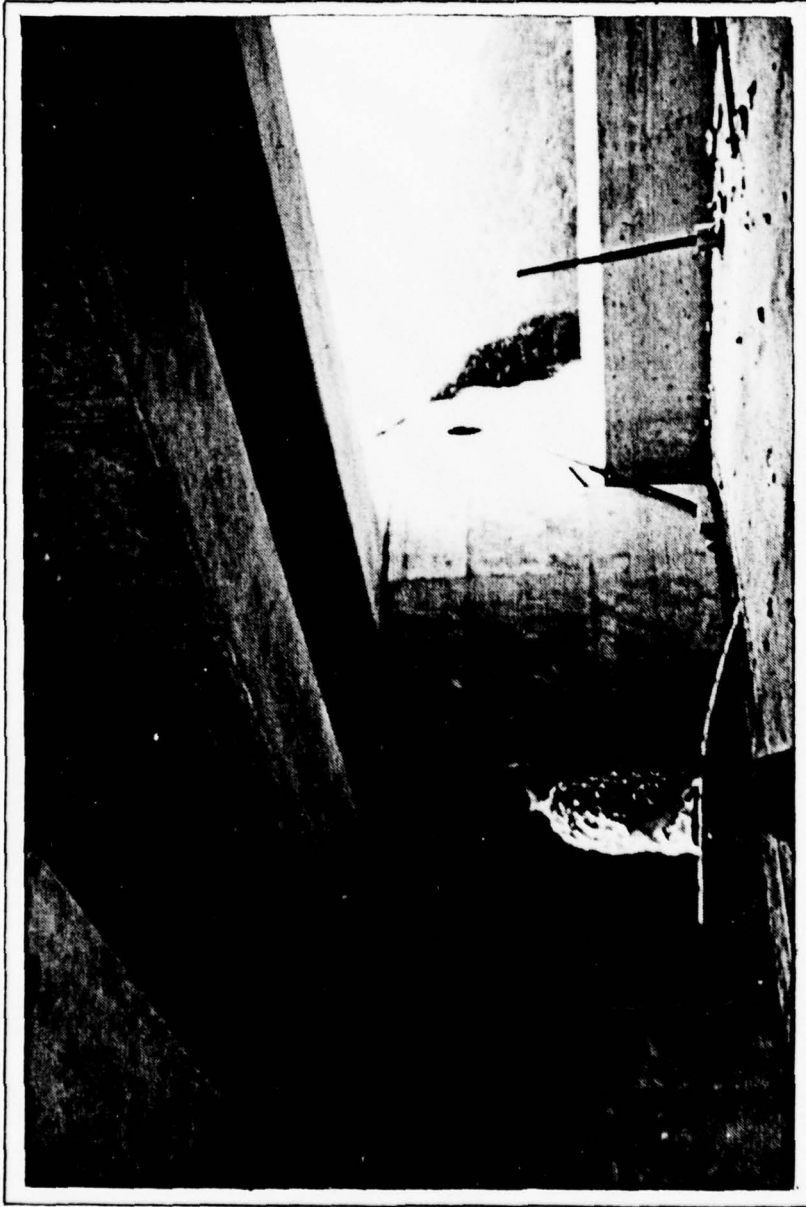
PHOTOGRAPH NO. 6

minimum vertical distance between the weir crest and the underside of the bridge is 6.5 feet compared to the 9.5 foot difference between the weir crest and the top of the dam. Thus, at heads approaching 6.5 feet, the bridge will start to have an effect on spillway discharge. Observations regarding the downstream channel, spillway condition and reservoir are located in Appendix B.

VIEW OF SPILLWAY. NOTE
CLEARANCE BETWEEN BRIDGE
AND OGEE SECTION.

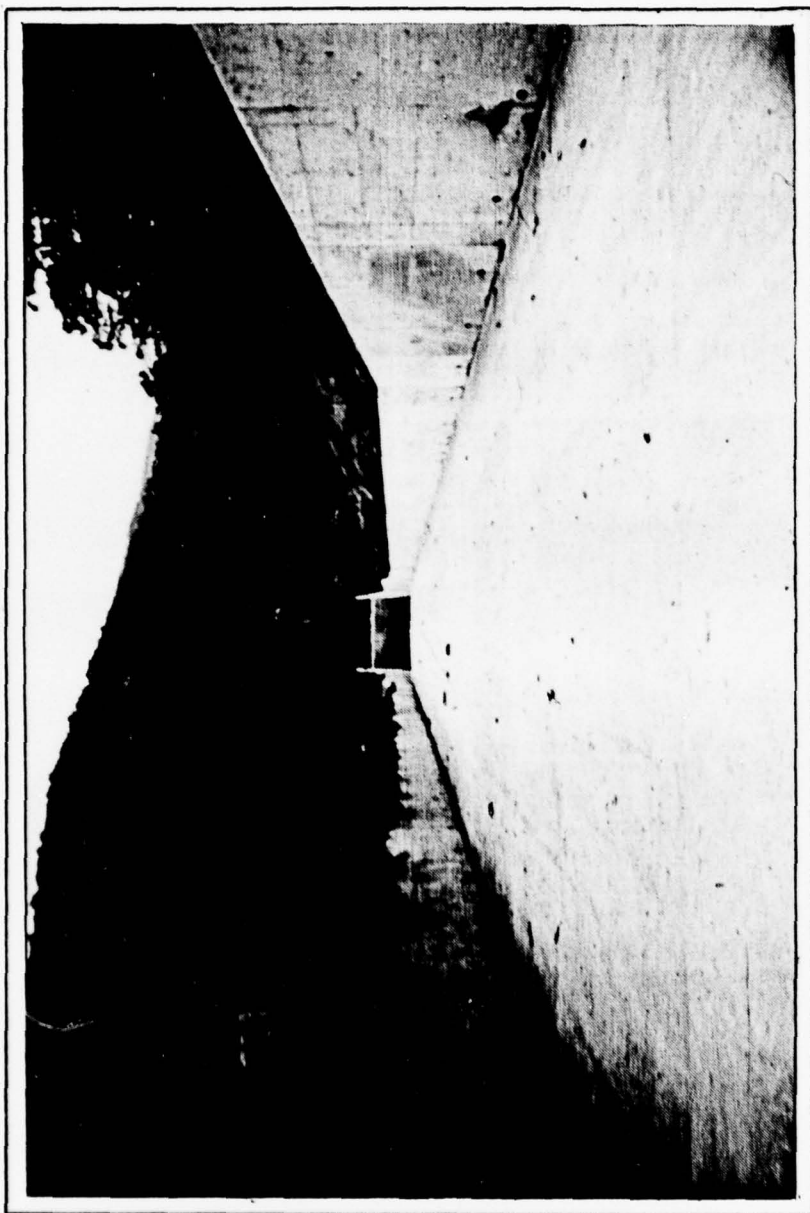
PHOTOGRAPH NO. 7

SPILLWAY DISCHARGE CHUTE
AND STILLING BASIN.

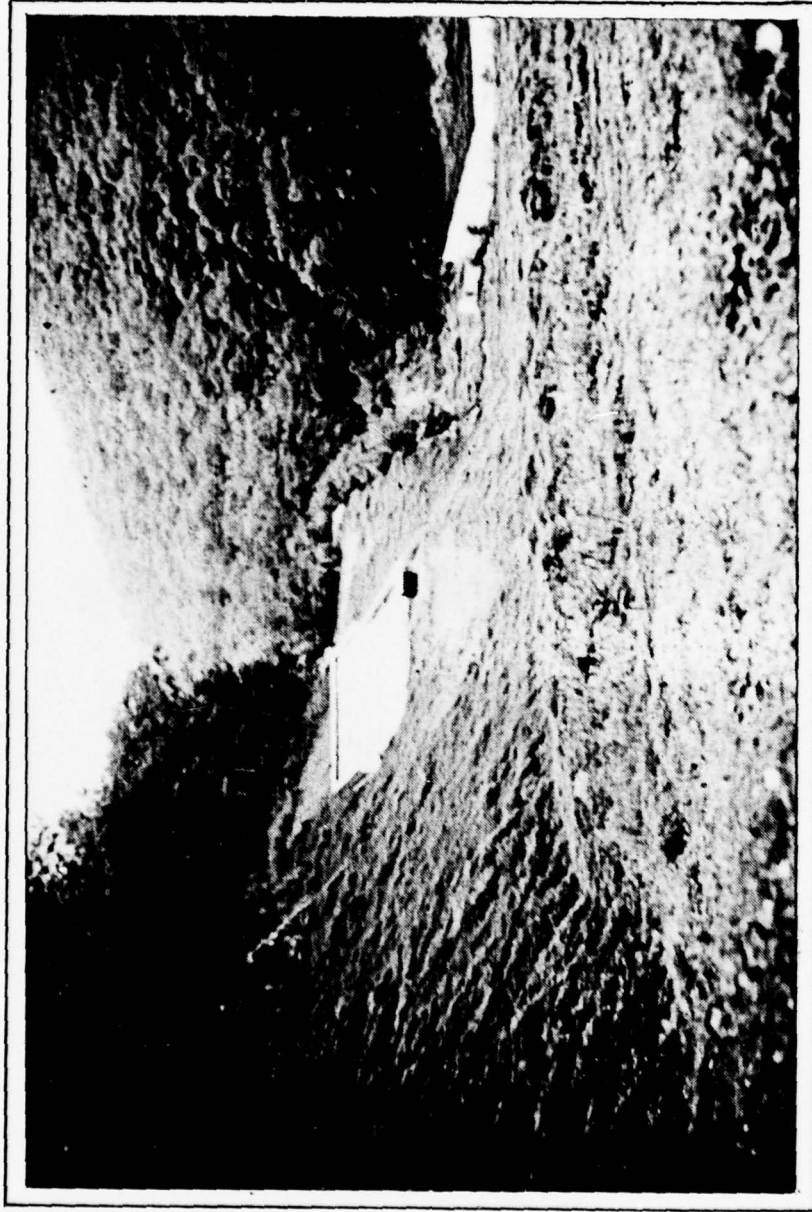
OVERVIEW OF PUMPHOUSE AND
DOWNSTREAM CONDITIONS.

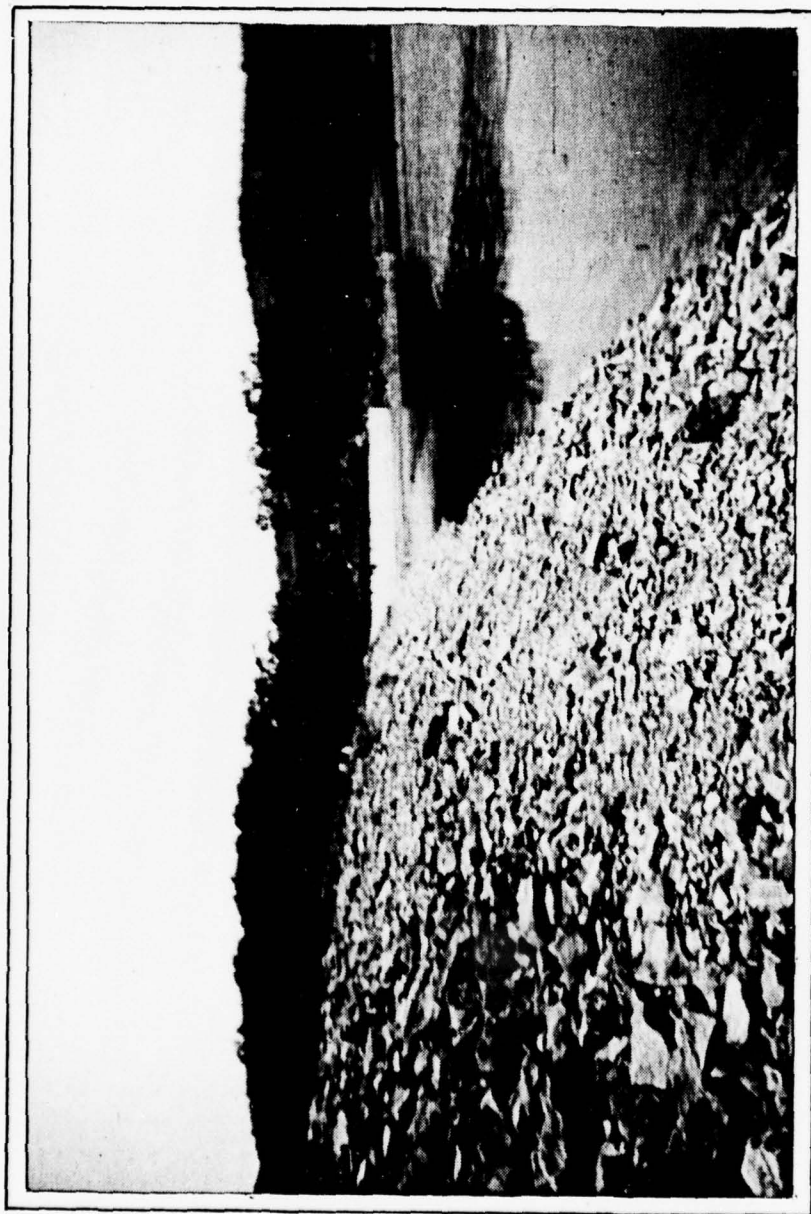
VIEW OF UPSTREAM SLOPE LOOKING
TOWARDS RIGHT ABUTMENT.

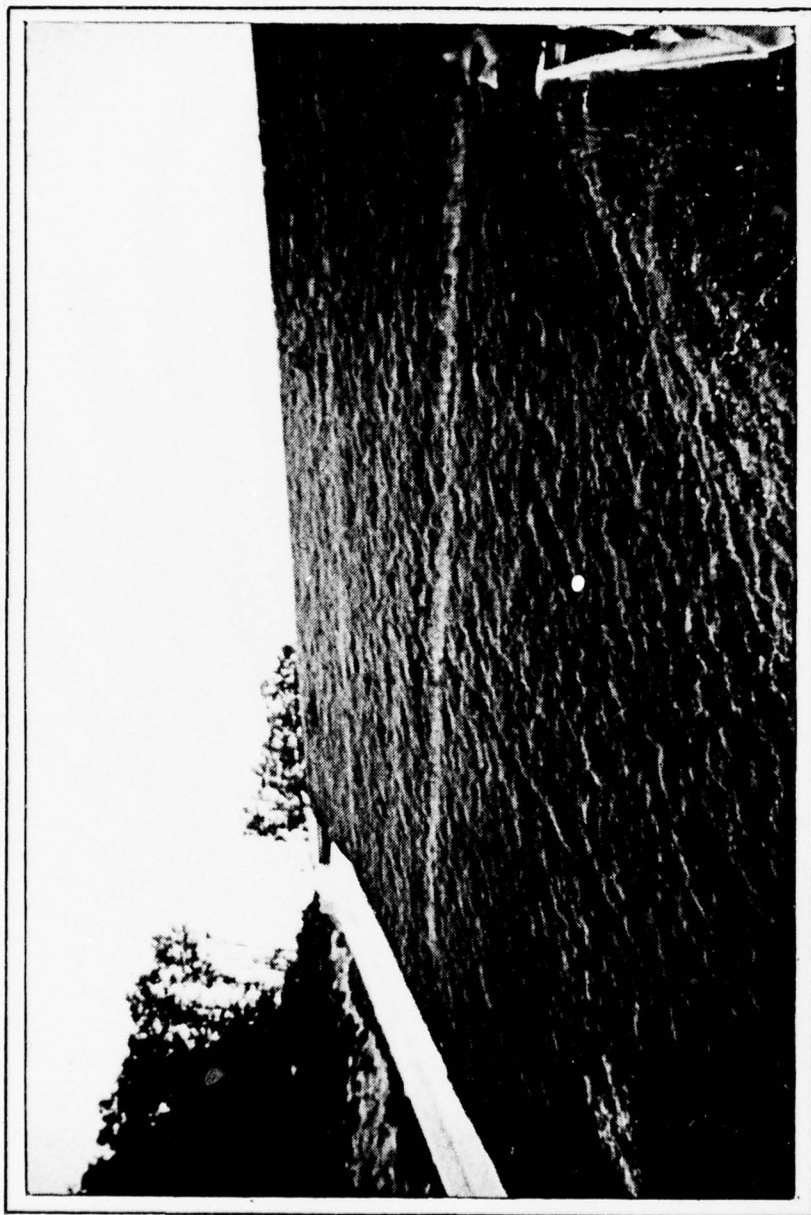
PHOTOGRAPH NO. 11

VIEW OF DOWNSTREAM SLOPE. NOTE
BENCH ACROSS MIDDLE OF PHOTOGRAPH
AND SEEPAGE ZONE IN LOWER LEFT
CORNER.

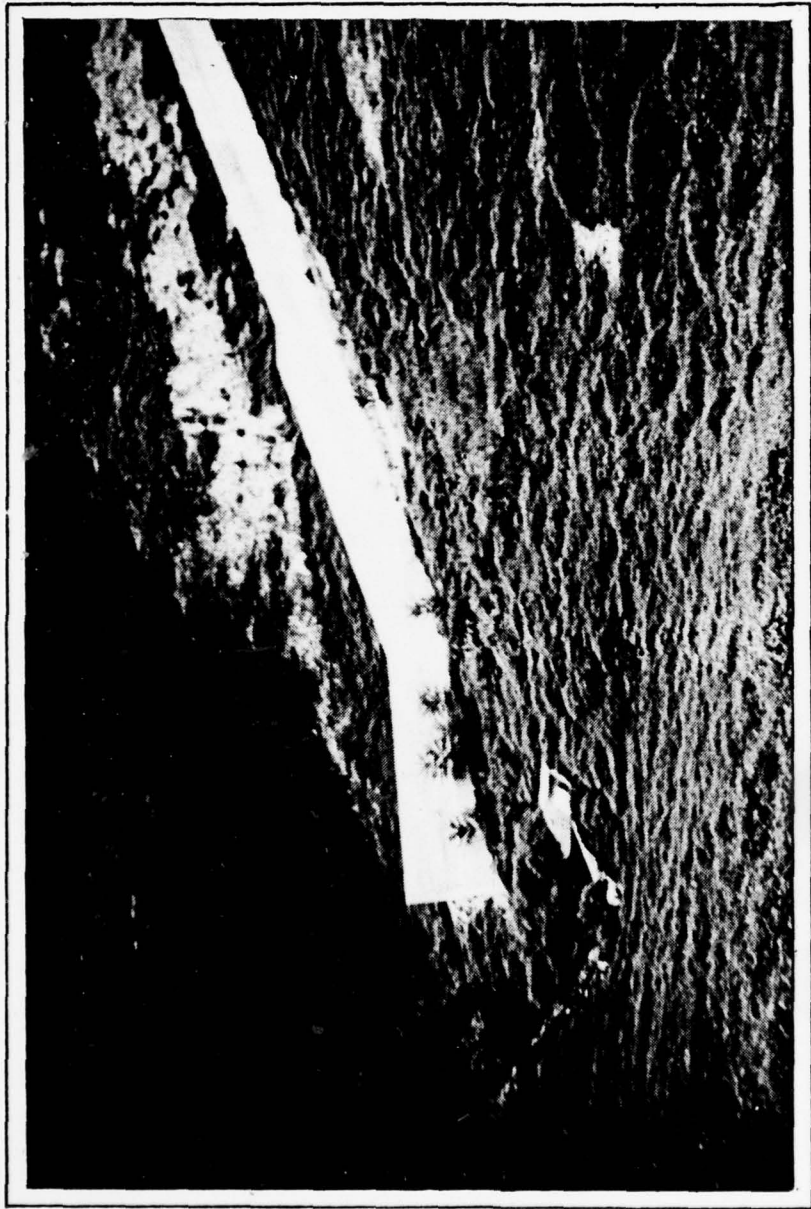
PHOTOGRAPH NO. 12

NOTE SEEPAGE ZONE ON DOWNSTREAM
SLOPE BY DIFFERENCES IN VEGETATION.

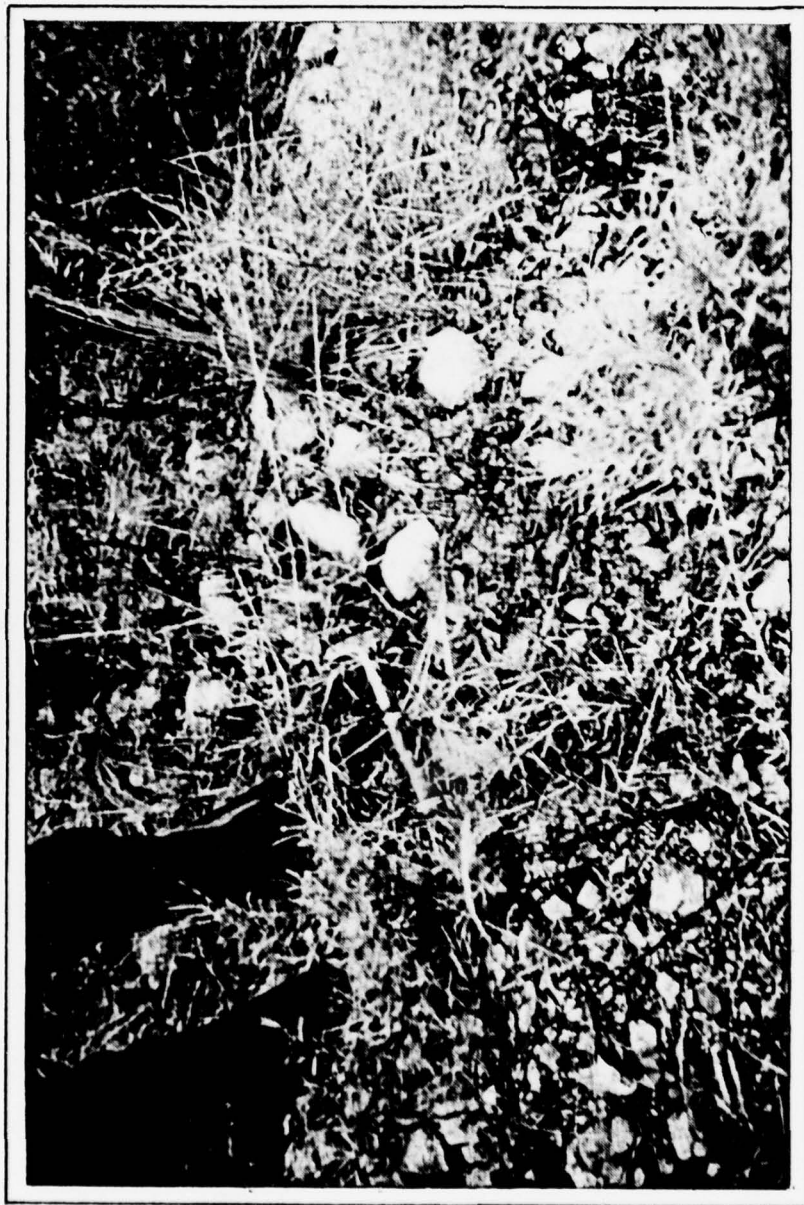
PHOTOGRAPH NO. 13

CLOSE-UP VIEW OF SEEPAGE
DESCRIBED IN PHOTOGRAPH NO. 12
